## MULTILAYER GEOGRID FOR CLAY REINFORCEMENT BLAIR, NEBRASKA

PROJECT NAME	Lagoon Clay Liner Reinforcement
LOCATION	Blair, Nebraska
PRODUCTS	MS500
OWNER	Cargill Corn Milling, Inc.
ENGINEER	Terracon Consultants

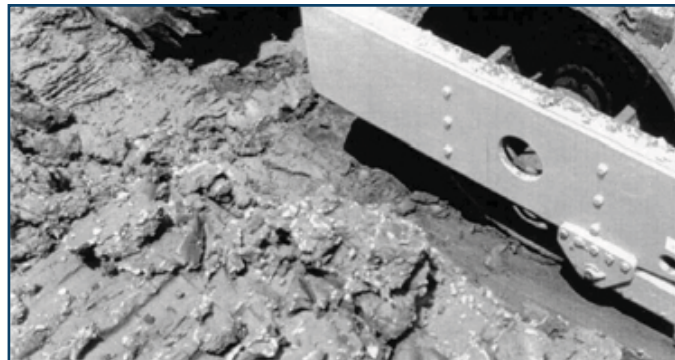
A 0.3m layer of non-processed on-site clay fill material was spread directly on top of the geogrid. The above figure shows the installation of the geogrid. A Caterpillar CP563 compactor was used to compact the fill soil. This unit has a single drum in front, driven by rubber tires on back. The compactor made 6 passes across the test area. A pass consists of a compactor travel over the area in one direction; the return to the original location was considered the second pass. The test revealed at this point we had an 89% compaction with a water content of 29.3%. After running 4 more passes over the same area, for a total of ten. The test revealed a 97% compaction with 27% water content. To verify this, a second test was done in an adjacent location, still in the test area, this test revealed a 98% compaction with 27% water content. Both tests exceeded 93% required compaction.

Field tests were conducted to evaluate the proposed solution for weak subgrade stabilization with a multi-layer geogrid. The testing section was at depth of 2.4m below the ground surface. The geogrid was placed in an area approximately 4.6m wide and 30m long. This area was determined to be one of the most unstable locations at the job site in reference to soil testing. The first 1.8m of soil was cut by scrapers and the final 0.6m of excavation was done using a smooth-edged backhoe bucket. When the test depth was reached, the soils were very soft, wet and sensitive to disturbance. Foot traffic on the weak subgrade caused pumping of soil moisture and left deep footprints. The above photo shows a compactor in the area that sank to the drum while attempting to compact a 0.3m lift of clay liner material placed on the weak subgrade.
